Article

Microstructure and Properties of Electroless Ni-P/Si₃N₄ Nanocomposite Coatings Deposited on the AW-7075 Aluminum Alloy

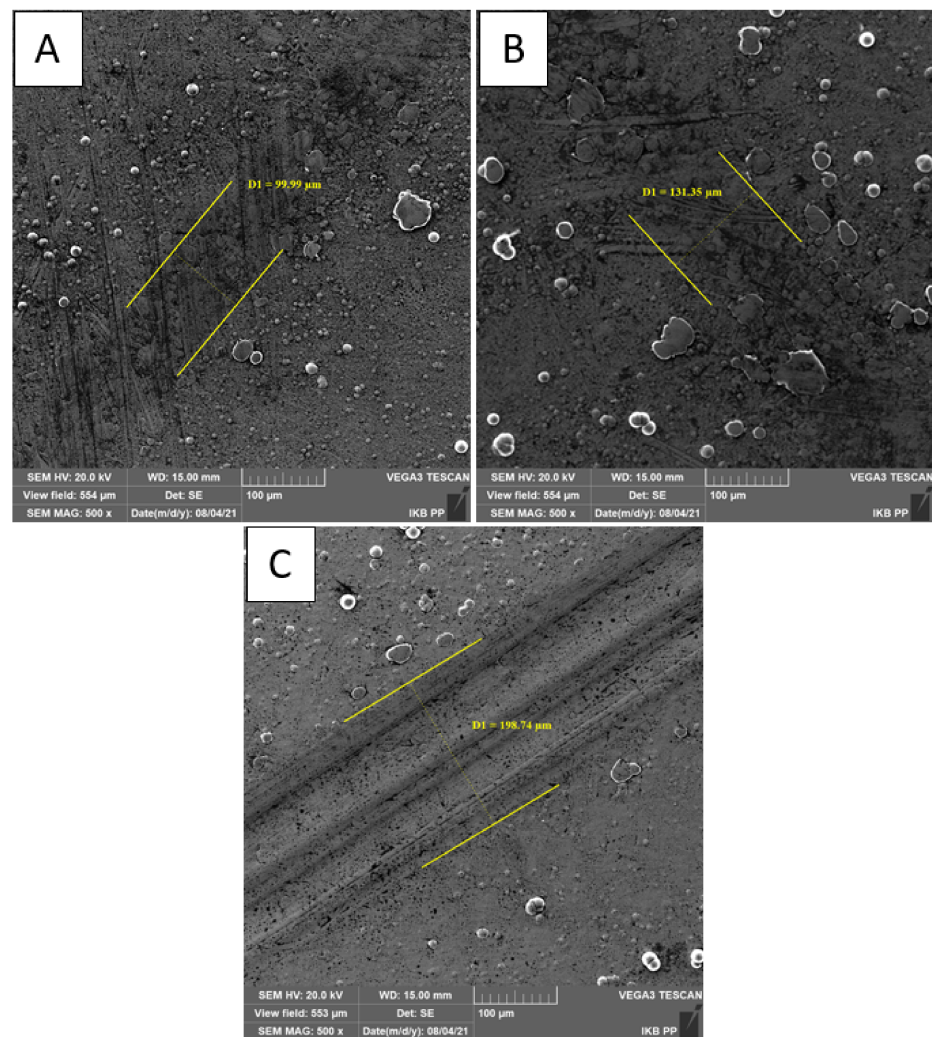
Figure 9. SEM Images of cracks for samples with NiP/Si₃N₄ coatings deposited in a bath with 5 g/dm³ Si₃N₄ (load: (A) 5 N; (B) 10 N; (C) 15 N; magnification: 500×).

Figures 7–9 show the results of tribological tests performed with the ball-on-flat method, which were carried out during 1200 s using GL-4 75W/90 semi-synthetic gear oil. All other parameters and wear diameters remained unchanged. Specialized computer software was used again, which is an integral part of the light microscope. The drawings show high-resolution microscopic images showing the width of the carved grooves to an accuracy of 0.1 μm.
