1
2 **1 Modernized cathodic protection system for legs of the production rig –**
3
4 **2**
5 **3 evaluation during ten years of service.**

33
34 15 The modernization of cathodic protection system of the Baltic Beta platform legs is described.
35
36 16 It was that the sacrificial anodes cone-shaped groups were to be placed on the seabed at a
37
38 17 depth of 80 meters. The measurements results of cathodic protection effectiveness during its
39
40 18 ten-years operation are presented. The effectiveness was assessed based on the potential value
41
42 19 along the entire length of the legs from the sea surface to the seabed. The gained experience
43
44 20 indicates that use of sacrificial anode systems mounted on the seabed can be an effective form
45
46 21 of cathodic protection of offshore platforms legs. It is basically the only means of
47
48 22 anticorrosion protection in case of a platform not able to leave its location for renovation
49
50 23 works in a shipyard.

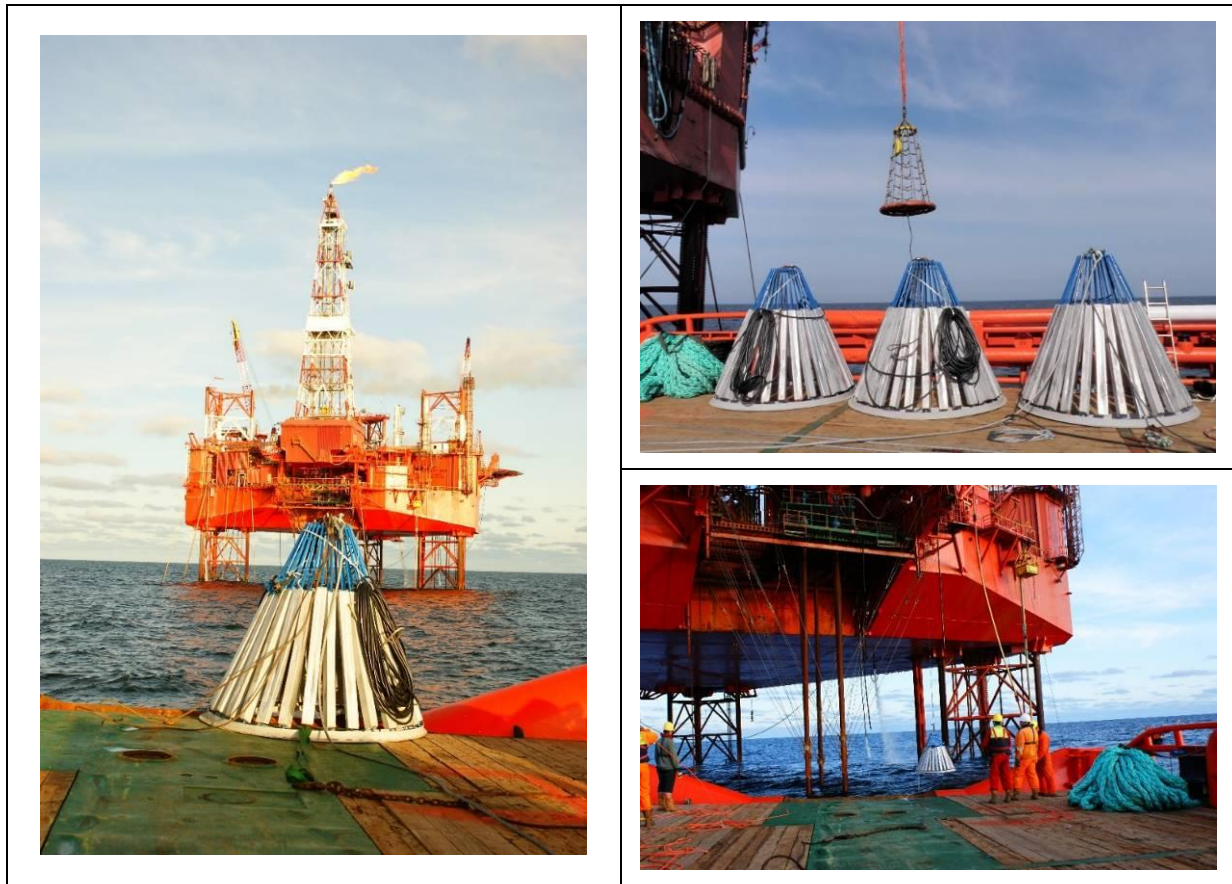
1
2
3
4
5
6
7
8
9
10
11
12
13
14
15
16
17
18
19
20
21
22
23
24
25
26
27
28
29 169
30
31 **Photos 1–3.** *The anode groups system installed during the modernization of cathodic*
32 *protection system of the Baltic Beta sea platform.*
33
34 171
35
36 172
37
38

31 162 Works related to mounting and connecting the anode groups were implemented in
32
33 163 September 2009. The task of placing the anode groups on the seabed required a cooperation
34
35 164 of tugboats, rig cranes and divers. The total time for assembly of the anode groups as well as
36
37 165 start-up of the installation was about one week. Photographs taken during the works in 2009
38
39 166 are included herein as Photos 1–3.
40
41
42
43
44
45
46
47
48
49
50
51

9 153 The existing sacrificial anodes welded to the legs of the platform in 1995 turned out to
10
11 154 be used up in about 50%, which has been confirmed by a visual inspection of an underwater
12
13 155 vehicle (so-called ROV – remotely operated vehicle). As an additional source of cathodic
14
15 156 protection current, sacrificial anodes groups were designed in the form of cone-shaped baskets
16
17 157 (see Phot.1-3), two for each leg, which were to be placed on the seabed at the distance of
18
19 158 about dozen meters from the legs (Zakowski, 2011). The anode groups were electrically
20
21 159 connected to the legs with a cable. It was assumed that the anode systems should provide
22
23 160 protection current for the next 10 years, therefore each group contains 30 aluminum anodes,
24
25 161 1.5 meters long and 45 kg each.
26
27
28
29
30

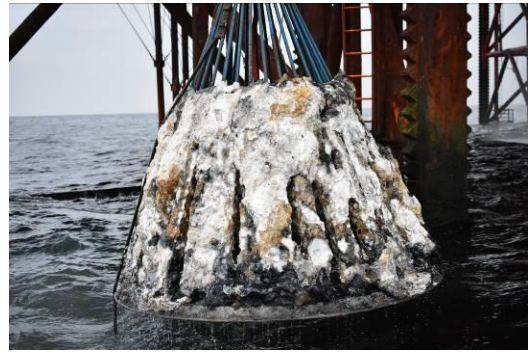
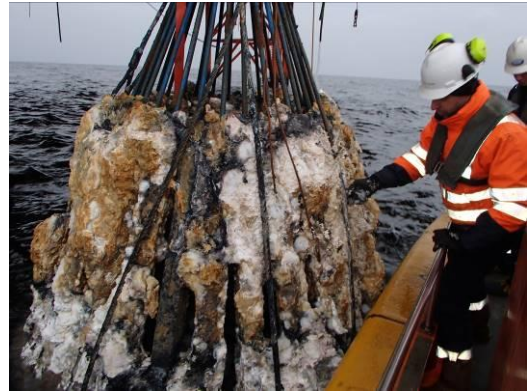
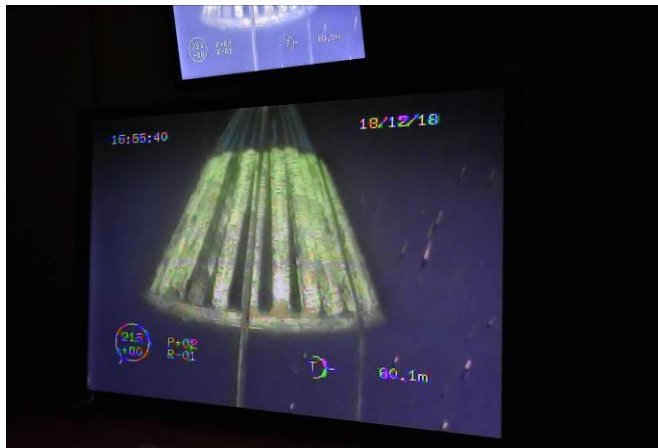
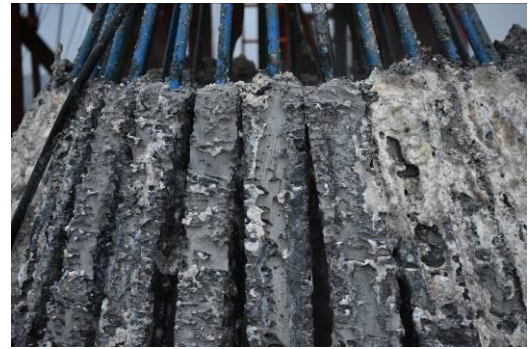
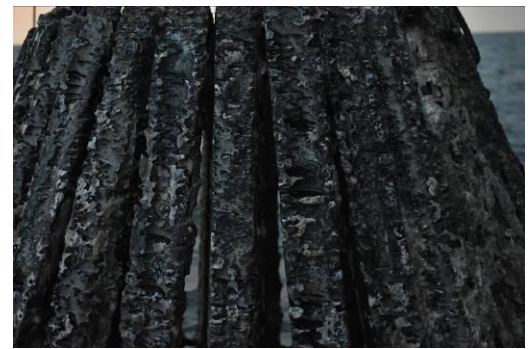
Photos 4–9. One of the cone-shaped anodes basket during a cleaning procedure carried out at sea. The upper three photos show the cone before hydro-cleaning, and the lower three photos show the cone after is cleaned.

280 Photos 4-9 show one of the cone during the cleaning process. Removing the overgrown
281 dissolution products was carried out by hydro-cleaning, all of the loose material was rinsed
282 off so that only the hard, unreacted protective alloy remained on the anodes. Information
283 gathered during each previous visual inspection, gave concerns about the amount of alloy left
284 on the anodes. After the cleaning process was finished it was clear that the amount of
285 protective alloy remaining on the anodes is about 50% of the original volume. After the
286 cleaning operation was completed, all of the cones were returned to their previous location on
287 the seabed.

270 Every time during potential measurements a close visual inspection of the anode
271 groups (cones) is carried out. These inspections indicated that all cones are working properly,
272 this is due to the fact that some products of aluminium alloy dissolution are overgrowing the
273 surface of the anodes. Such deposits can reduce the flow of protection current from the
274 anodes, this phenomenon is unwanted when it comes to corrosion protection. In order to
275 obtain the original operating parameters of the anodes, it is necessary to clean them of the
276 anode dissolution products. Due to their design, anode cones can be lifted and moved from the
277 seabed, this property has been useful several times before during their lifetime. This ability is
278 very useful and practical for any this type of objects when it comes to operating a platform at
279 sea. In 2018, a decision was made to recover the anodes cones for a cleaning operation.
