Monitoring of underdeck corrosion by using acoustic emission method

Krzysztof Emilianowicz, M. Sc.,
Gdańsk University of Technology, Poland

This paper presents first short characteristics of underdeck corrosion process as well as a problem of its monitoring. Next is described an acoustic emission (AE) method elaborated by Department of Ship Technology, Quality Systems and Material Engineering, Gdańsk University of Technology in cooperation with partners of CORFAT project realized within 7th EU Frame Program. Further are presented short characteristics of the emission process, used measuring instrumentation of Vallen Systeme GmbH, as well as TESTER, corrosion testing device, and a corrosion solution used in the tests. Finally, results of the tests performed on selected marine units, are presented.

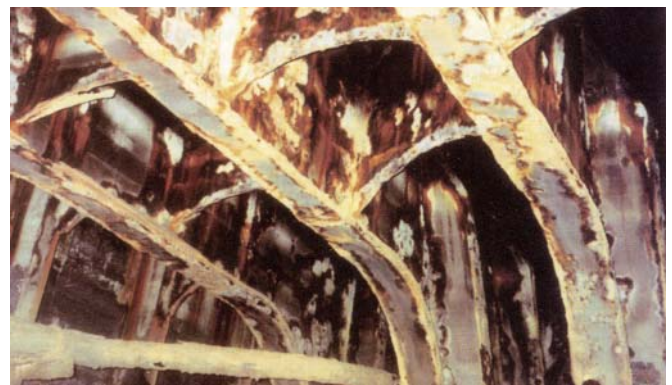
Fig. 1. An example of ship underdeck corrosion [5]

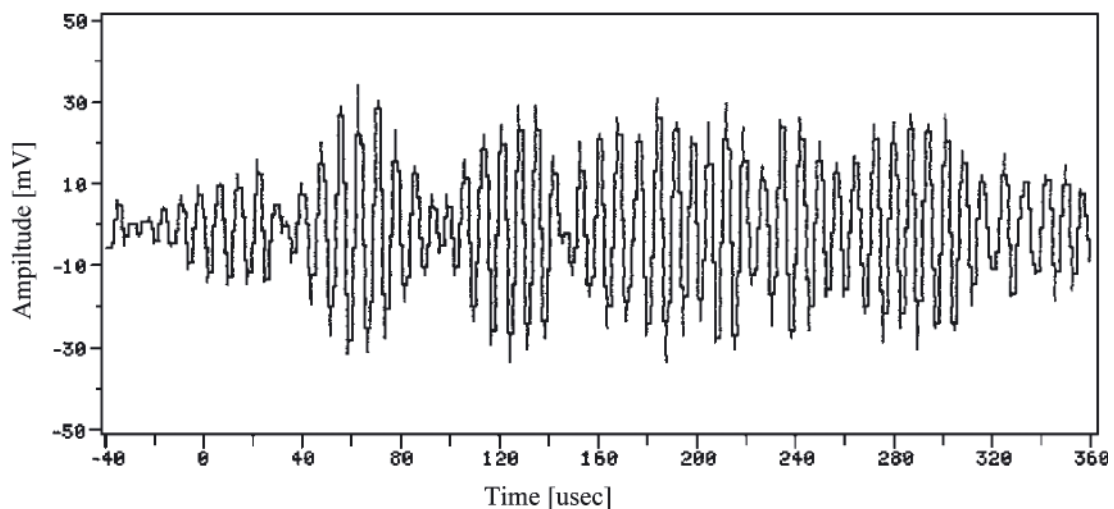
Fig. 3. Run of reflected wave [4]

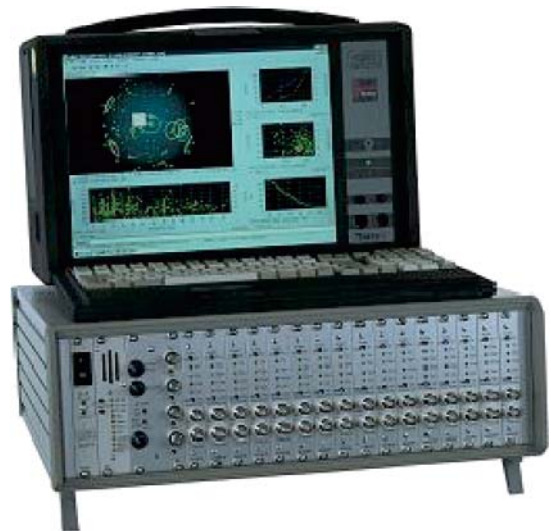
Fig. 6. AMSY-5 system of Vallen Systeme GmbH for AE testing [2]

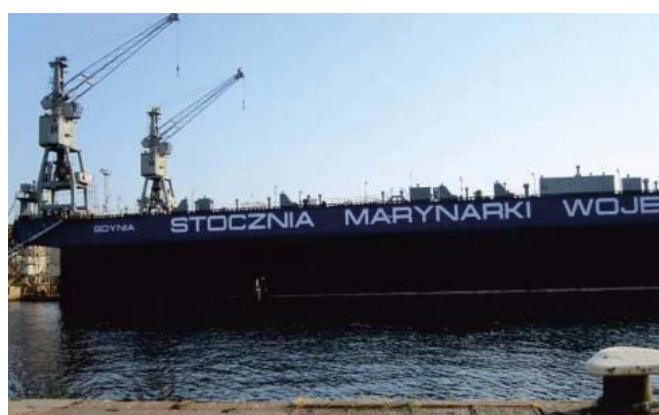
Fig. 11. Schematic diagram of arrangement of sensors and corrosion testers inside the tank No. 11 of the Naval Shipyard Co floating dock

The corrosion tester was placed overhead on tanktop internal surface, about 100 mm from a manhole; additional AE sensors (measuring signal coming directly from the GUT

tester) were located on external surface, about 300 mm from corrosion source, directly over the tester.

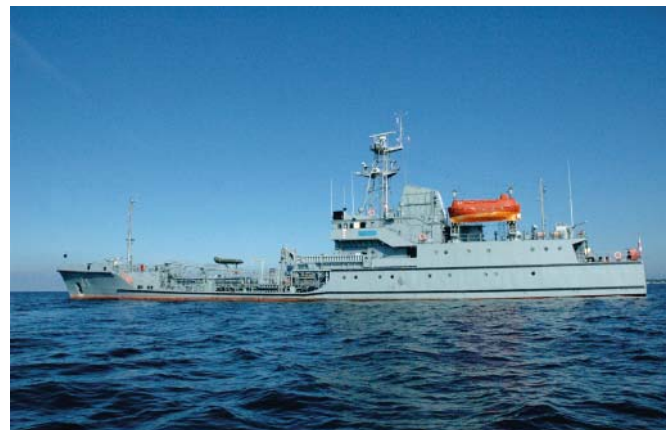
Fig. 14. Location of the test site (the tank No. V12 of cofferdam) and arrangement plan of the sensors on the deck of the Polish Navy tanker „Bałtyk”

The next place of the tests was the tank V12 of cofferdam on the Polish Navy tanker „Bałtyk”. On the contrary to the earlier tests it was not allowed to locally remove paint coating, that was however taken into account during measurements. Also, no data on paint coating thickness were available because it was impossible to get access to painting documentation of the ship. Thickness of the plate was equal to about 6 mm.
