Portico farmhouses of the Vistula Delta: architecture, current state and finite element modelling of timber roof truss under material and cross-section uncertainty

This is the accepted version of an article published in Journal of Architectural Heritage doi <https://doi.org/10.1080/15583058.2021.1918285>. The final publication is available online: <https://www.tandfonline.com/doi/full/10.1080/15583058.2021.1918285>

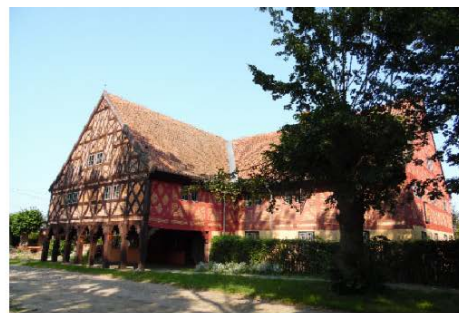
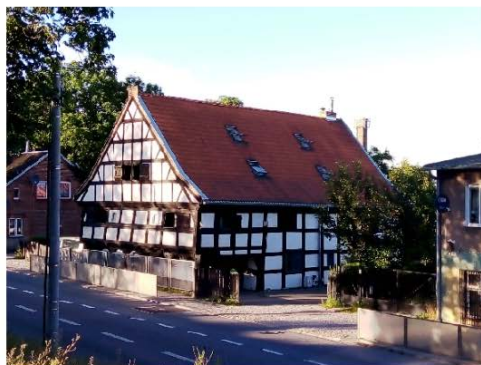
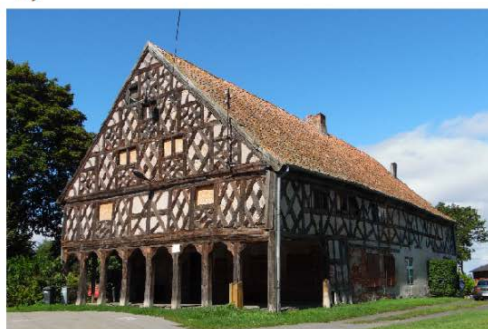
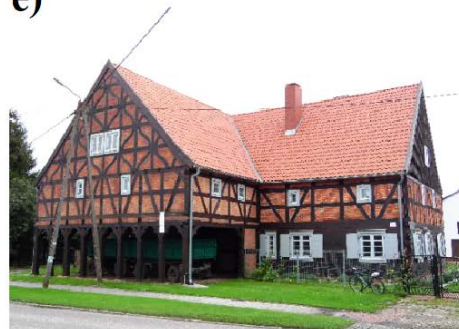
Figure 1. Three types of houses; a) 1, 2 – “I-type” house, 3; The portico houses in: b) Gdańsk Lipce c) Klecie d) Trutnowy e) Miłocin f) Nowa Kościelnica

Kloeppel (1924) differentiated three basic types of houses, (Figure 1a). It should be noted that the term *portico* should be treated somewhat conventionally here, and in some cases, the term *arcade* might be substantiated. In the building of the first and second type, the portico constituted the facade of the house, so we can call them I-type houses. The second type was in fact a result of the development of the I-type plan by adding a wing to the body of the house. Therefore, for this study they can also be classified as

The oldest preserved house in Lipce by Gdańsk (Germ. Guteherberge) was built ca 1600 (Kloepfel 1924 ; Bertram, Kloepfel, and La Baume 1924), (Figure 1b). The newest houses, retaining traditional style and proportions, come from the 1840 (Woede 1980).

by Gdańsk (Germ. Guteherberge) (Figure 1b), Klecie (Germ. Klettendorf) (Figure 1c), Trutnowy (Germ. Trutenau) (Figure 1d), Miłocin (Germ. Herzberg) (Figure 1e), Nowa Kościelnica (Germ. Neumünsterberg) (Figure 1f).

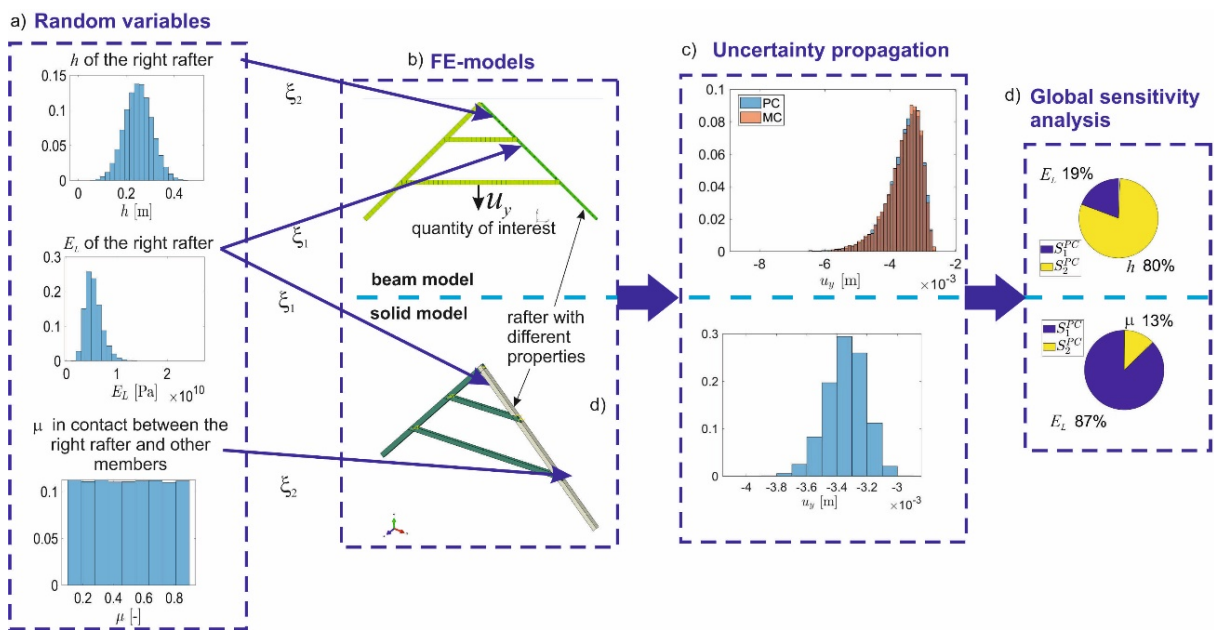
Figure 8. Scheme of uncertainty quantification and sensitivity analysis.

Sudret (2007). The probabilistic approach is used to investigate the influence of input uncertainties on the truss mechanical behaviour. The framework applied before to study traditional carpentry corner log joints by Kłosowski et al. (2018) is employed here. Firstly, FE models of the truss are built (Figure 8b). Uncertain inputs are identified and random input vectors are defined (Figure 8a). Next, uncertainties are propagated through the models (Figure 8c). Then, the influence of random variables on the output variance is assessed by the global sensitivity method (Figure 8d).

The output on which the analysis is focused (quantity of interest) is a displacement u_y (displacement along the gravity direction) of the node on the collar beam (Figure 8b), where the displacement for the mean parameters is the highest. The reason is that the serviceability limit states is more often cause to investigate timber structures than ultimate limit states (Morales-Conde and Machado 2017).

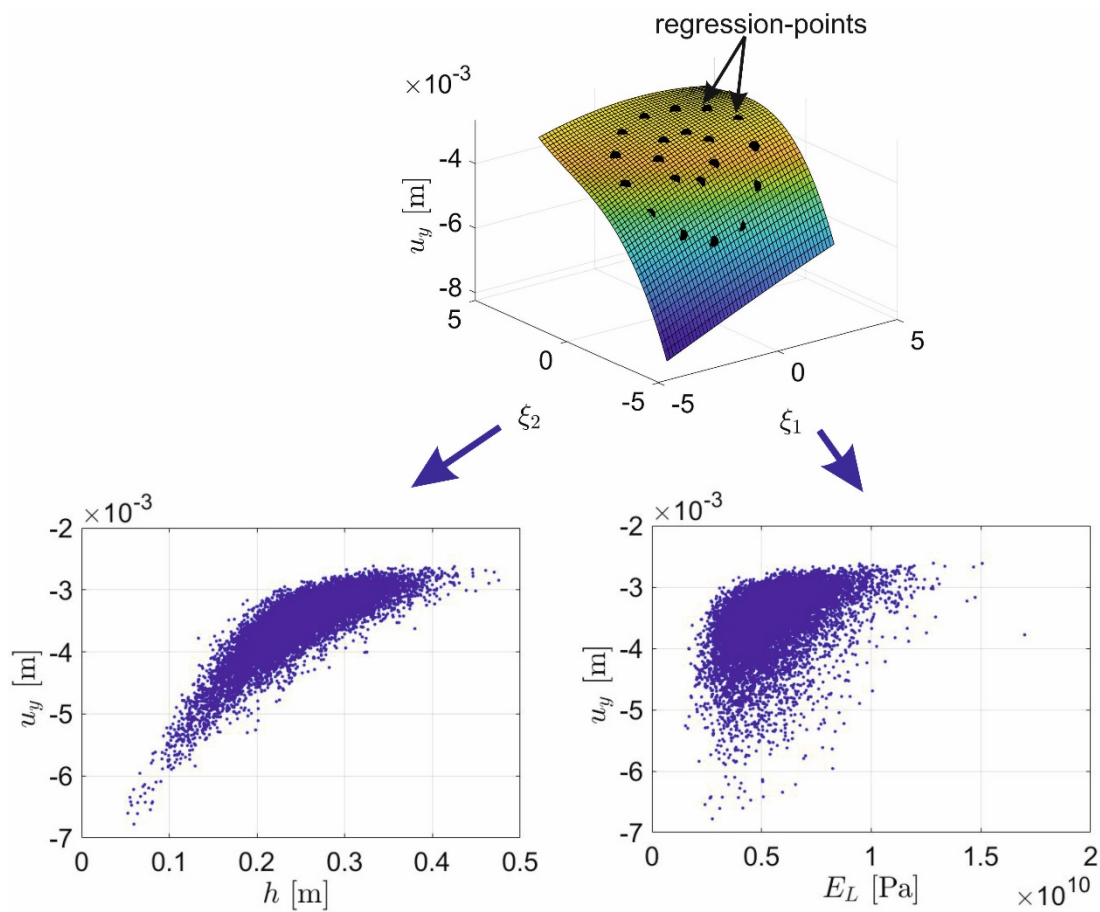
Figure 10. PC meta-model of quantity of interest obtained by the beam model with regression points marked (top) and scatter plots of MC sampling points (bottom)

In case of the beam model, a high value of $S_2^{Tot} = 0.81$ indicates that uncertainty of h has high influence on the variance of the output quantity of interest when compared to the uncertainty of E_L ($S_1^{Tot} = 0.2$). From the point of view of conservation practice, this conclusion may be seen as favourable, because it is easier to measure accurately cross-sections of the timber members than to non-invasively identify Young modulus. It should be noted, that a higher influence of h is obtained despite lower input variation of h .
