PROTECTION AND RENOVATION OF PUBLIC AREAS IN A MODERNIST CITY: THE CASE OF THREE STREETS IN THE HISTORIC CITY CENTRE OF GDYNIA

ABSTRAKT: This article concerns issues related to the preservation and restoration of public space in Gdynia's city centre, which was designed and built mainly in the 1920s and 1930s. In 2007, a major part of the city centre was entered into the register of monuments as a historic complex of urban architecture. Moreover, in 2015, the area was declared a Monument of History. Protection of a complex of urban architecture covers not only the renovation of historic buildings but also the protection of public spaces that comprise an integral part of the historic complex. Therefore, preservation of the historic shape and design of public space in the centre of Gdynia is one of the city's key conservation tasks. Since protection of urban space in relatively young historic centres (less than a hundred years old) is a novel issue from the perspective of conservation, it is therefore worth analysing. Issues connected with the protection and restoration of public space in the centre of Gdynia are exemplified by three historic streets, built in the late 1920s and loca

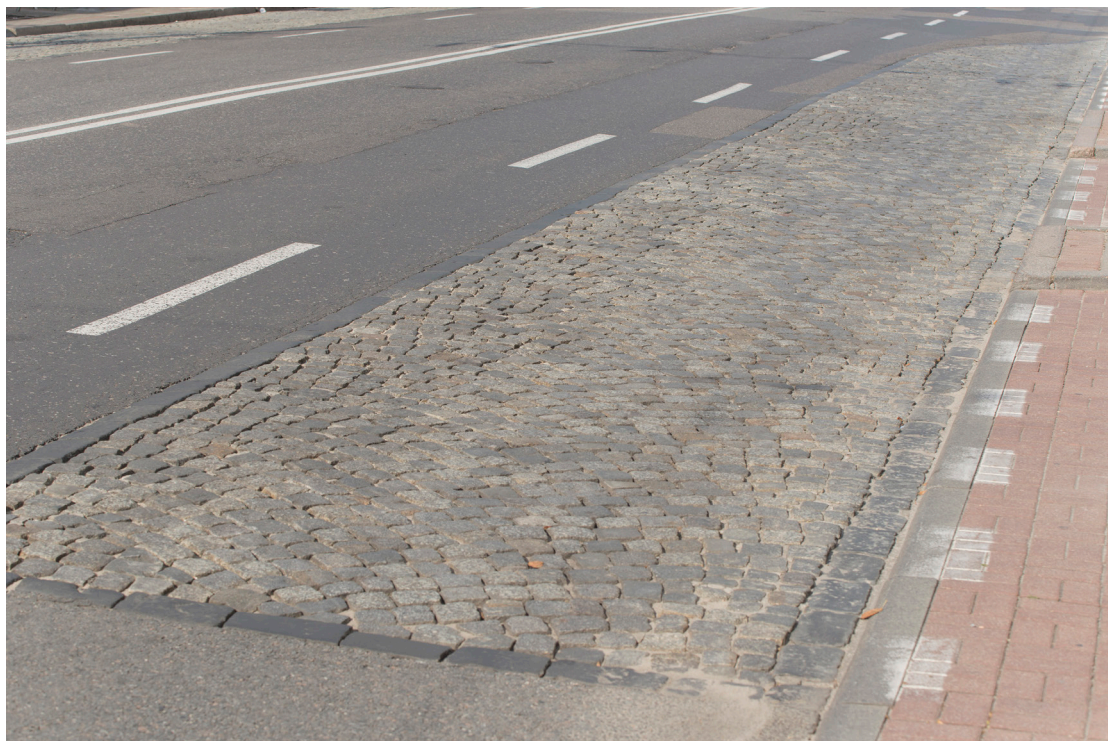
Fig. 2. Gdynia, 10 Lutego Street, historic road surface at the turn of the 1920s and 1930s, where asphalt was combined with cobbled side lanes; photo by B. Ponikiewski.

Apart from the main cobblestone lanes, which testify to the unique character of the street, no original pavement surface or other elements of the arrangement have been preserved.⁸ No historic reinforced concrete lampposts have survived as these have been successively replaced throughout the city since the 1980s. At the beginning of the twenty-first century most of the trees were cut down to create parking bays.
