## REDUCTION OF DERIVATIVE PIPELINE EFFORT IN WATER TURBINE

**Abstract:** The article presents an approach to evaluate and reduce the effort of the derivative pipeline in a water turbine of a hydroelectric power station in its vulnerable spots. Potential places of the biggest effort of the structure, as well as the coefficient of displacement and safety factor related to them were identified using FEM numerical method. Pipeline reinforcement was designed and made based on FEM analysis and non-destructive tests.

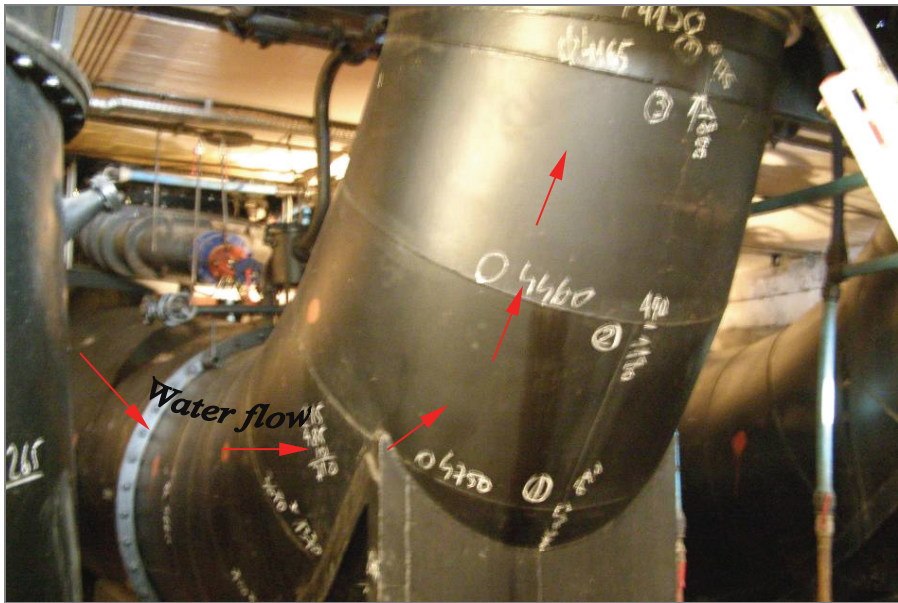
Rys. 2. View of water inlet pipelines.

A general view of the water turbine generators of the hydroelectric station discussed is presented in Fig. 1. Figure 2 shows the view of water inlet pipelines between the turbo generators. A draft with selected dimensions is shown in Fig. 3.

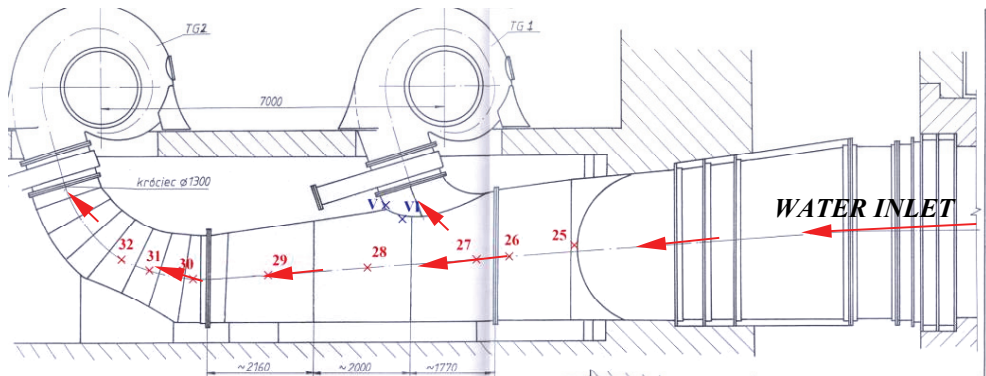
Fig. 3. Longitudinal section through the inlet pipe.

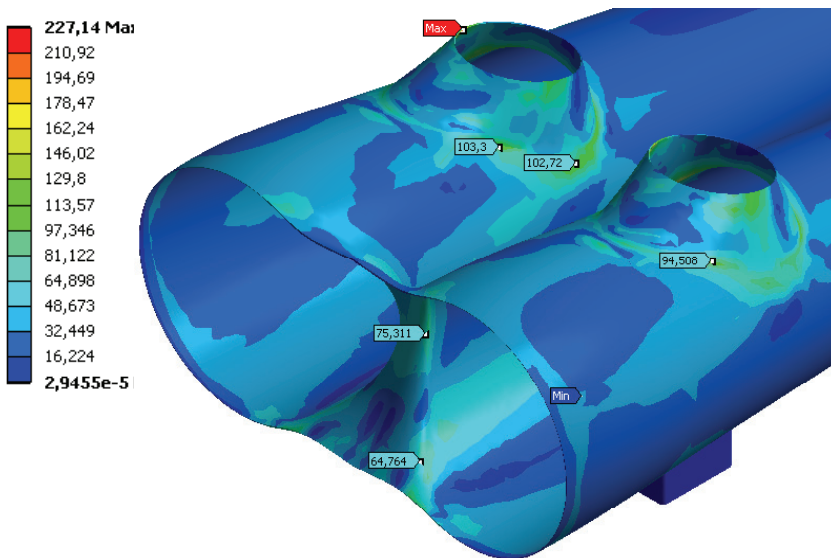
The previous results have revealed the necessity for the reinforcement of the branch and the inlet connection pipe. Initial simulation of the reinforcement (Fig. 11) has shown that an increase on the wall thickness of the branch and the connection pipes reduces the stress by half and therefore lowers the stress much under the tensile strength even in failure state under a 0.21 MPa pressure.

Fig. 11. Reduced stress for 0.21 MPa and an increase in local thickness of the branch and inlet pipes.
