A. Zieliński, A. Dziadoń¹, W. Serbiński, M. Jażdżewska

SURFACE CRACKING OF LASER MELTED Ti-6Al-4V ALLOY

ABSTRACT

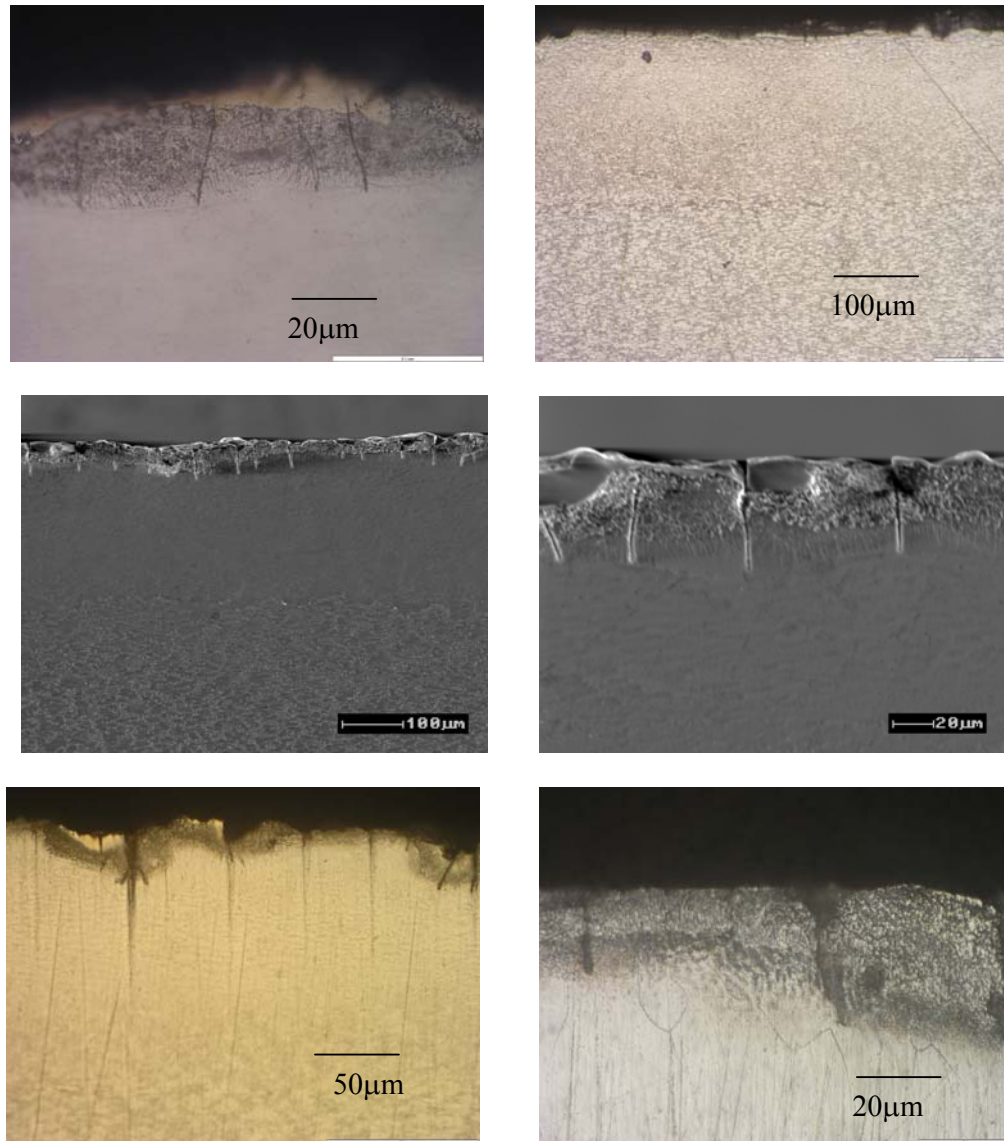
Fig. 1. Cracking of surface layers for specimens laser melted with CO₂ laser in liquid nitrogen at scan rate 1 m/min at power input (from top to the bottom): 3 kW, 4 kW, 5 kW and 6 kW

The results of performed tests are shown in Figs. 1-4. For every combination of tests parameters the view of the melted surface and cross-section are put together.

The cracks are evident to form at each condition. The depth of the crack is dependent on all variables. Generally, the higher power input and the lower scan rate, the longer cracks. The environment has also an effect: cracks are more significant during laser treatment in air and water. Pre-heating diminishes the cracking. The depth of the crack is always a significant portion of the melted zone and from this point of view, the laser melting in liquid nitrogen seems the most appropriate. The quantitative data are estimated and will be published in future.

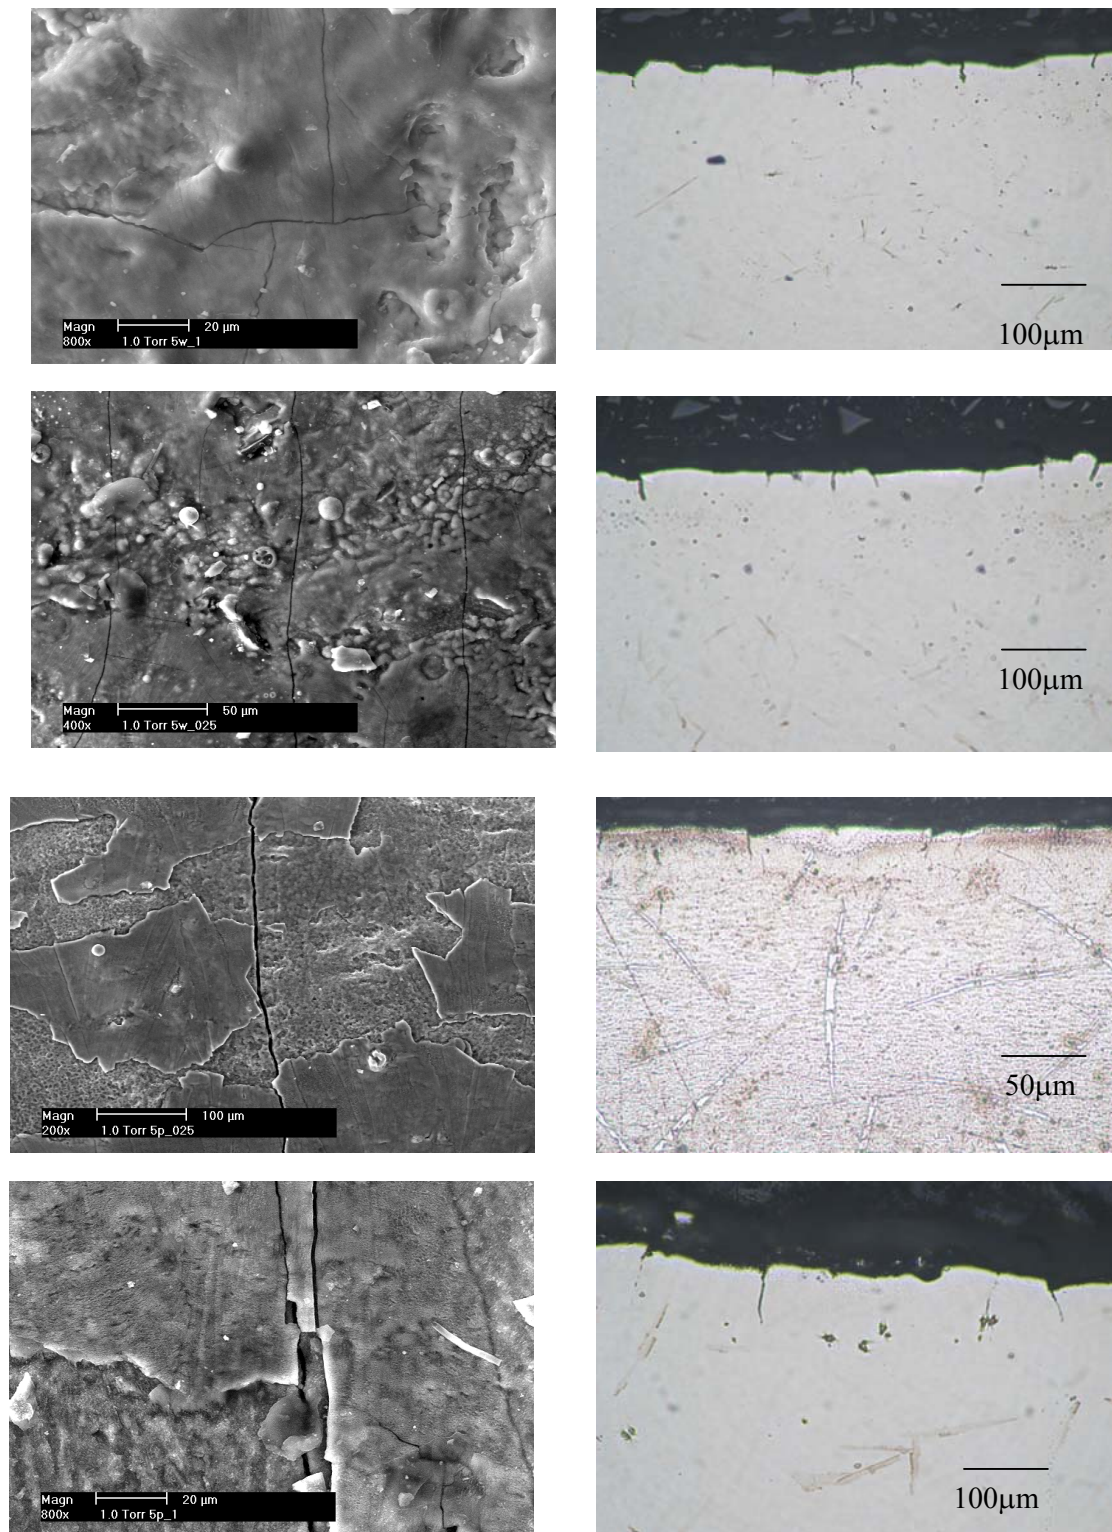
Fig. 2. Cracking of surface layers for specimens laser melted with CO₂ laser at 5 kW (from top to the bottom): in water at scan rate 1 m/min.; in water at scan rate 0.25 m/min.; in air at scan rate 1 m/min.; in air at scan rate 0.25 m/min

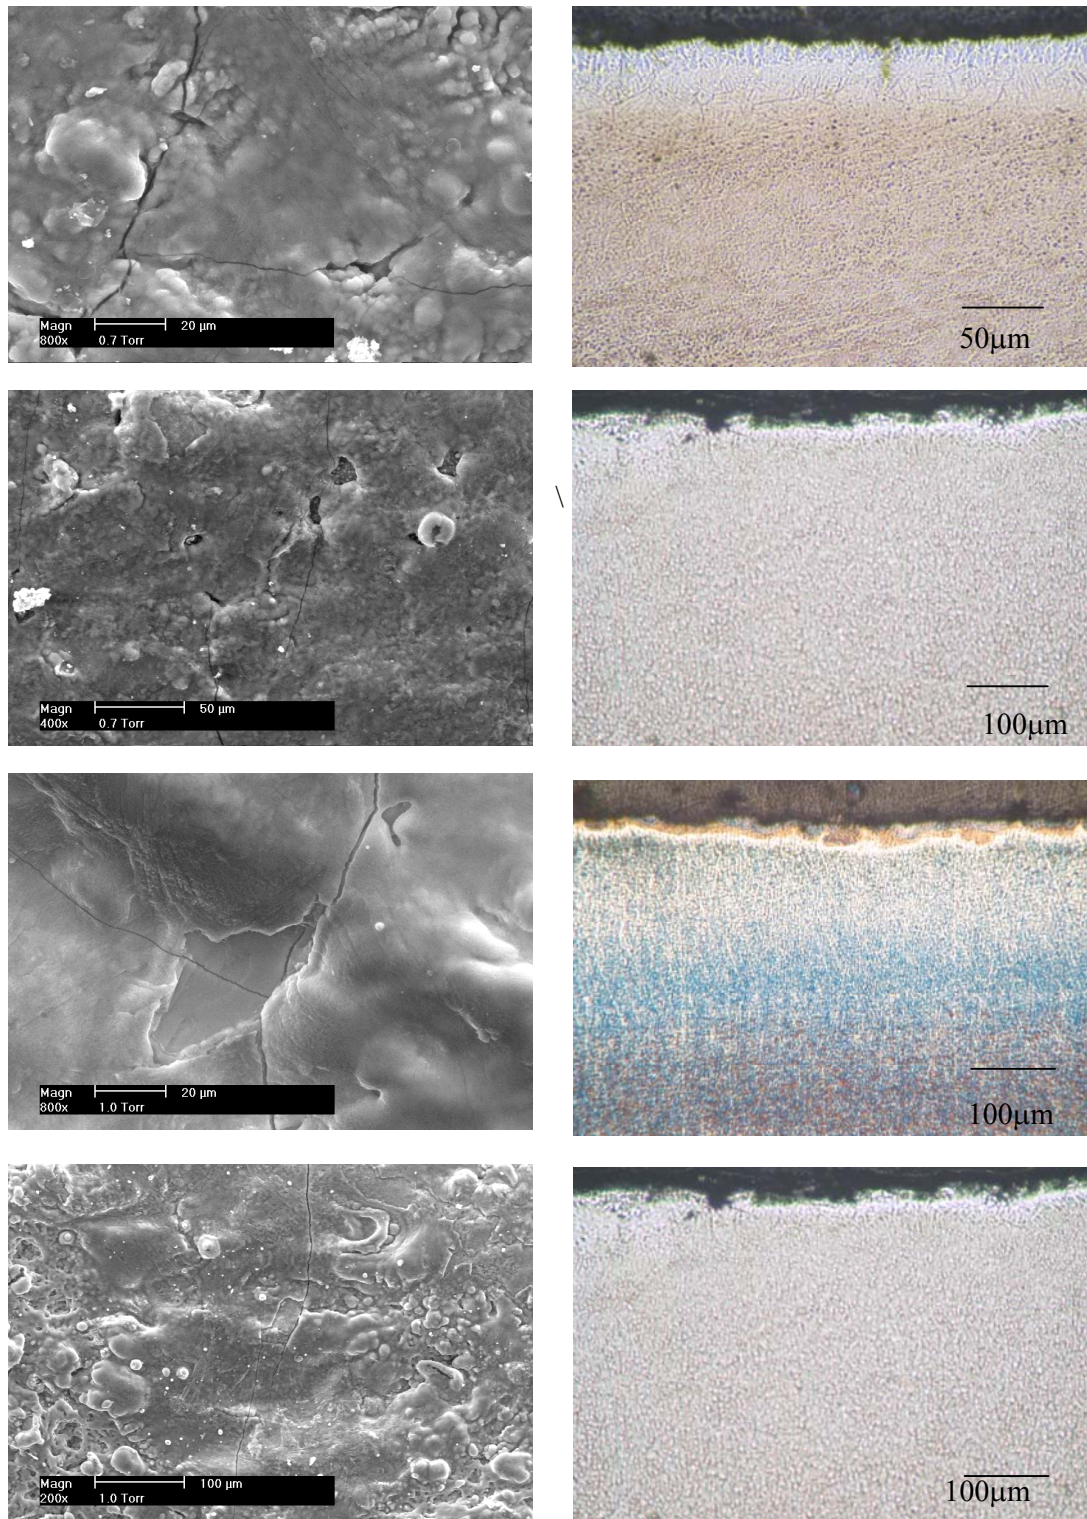
Fig. 3. Cracking of surface layers for specimens laser melted with CO₂ laser in air at 5 kW, at 1 m/min. scan rate and after pre-heating at temperature (from top to the bottom): 200, 300, 450 and 550 °C

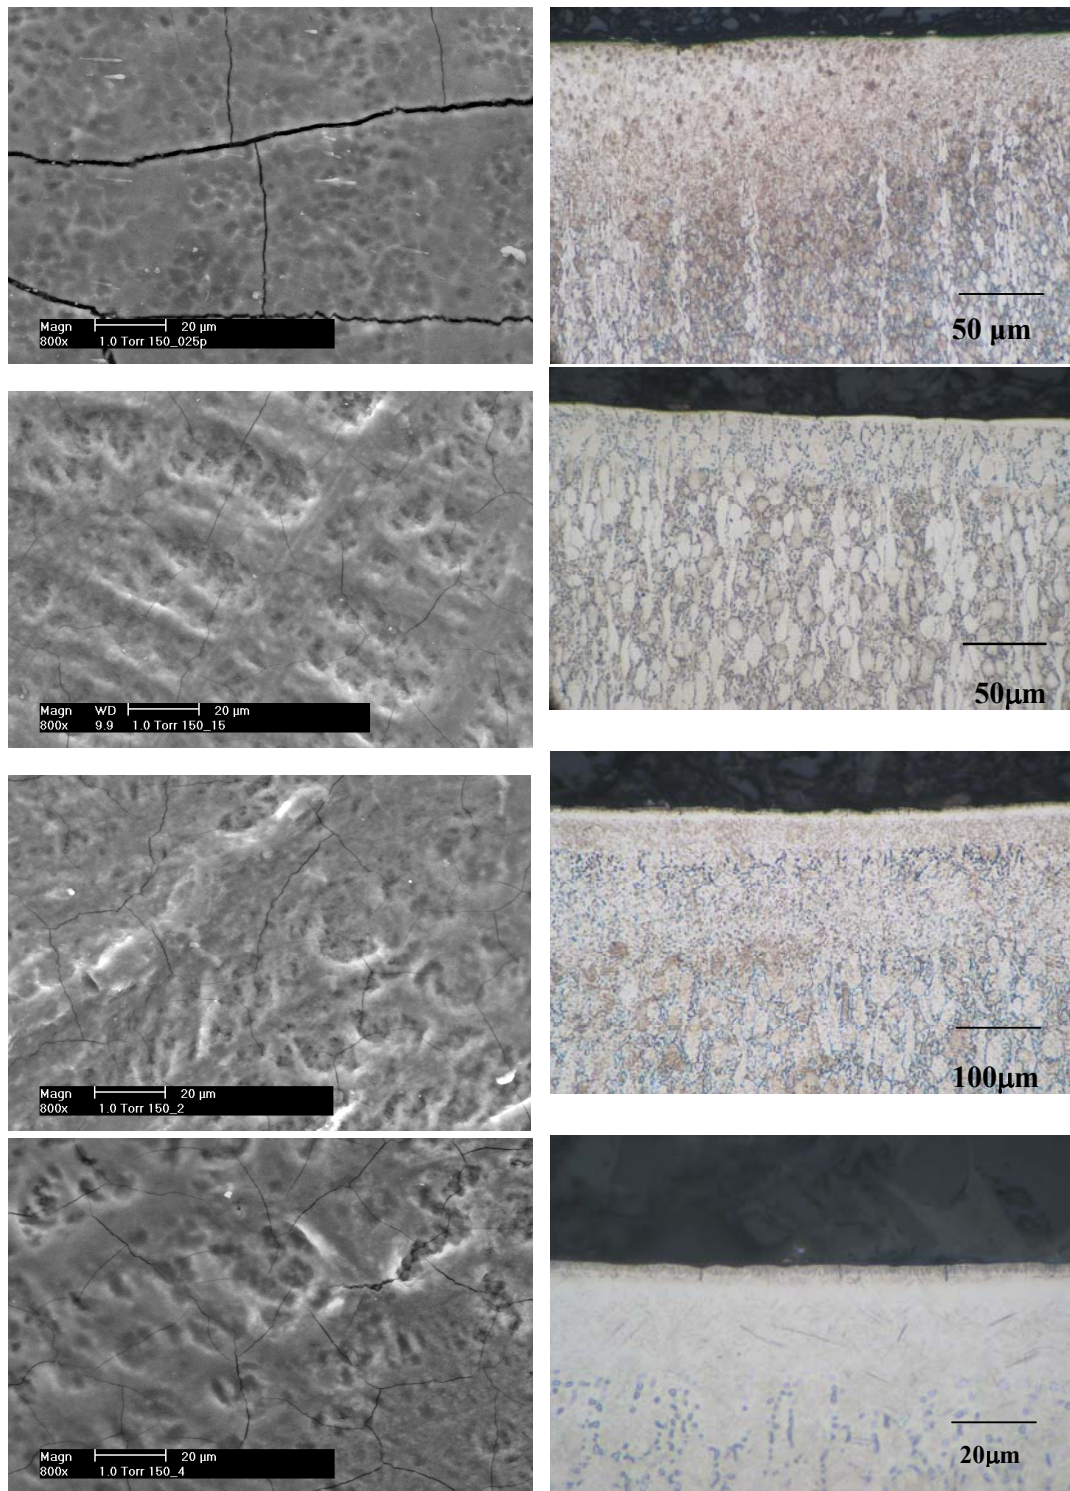
Fig. 5. Cracking of surface layers for specimens laser melted with Nd-YAG laser at 150 W and 50 Hz, without overlapping (from top to the bottom) at scan rate: 0.25 m/min., 1.5 m/min., 2 m/min, 4 m/min
