Technical Limitations in Merging Secular and Sacred Functions in Monumental Churches

Ksenia Piatkowska¹

¹ Gdansk University of Technology, Narutowicza 11/12, 80-233, Gdansk, Poland

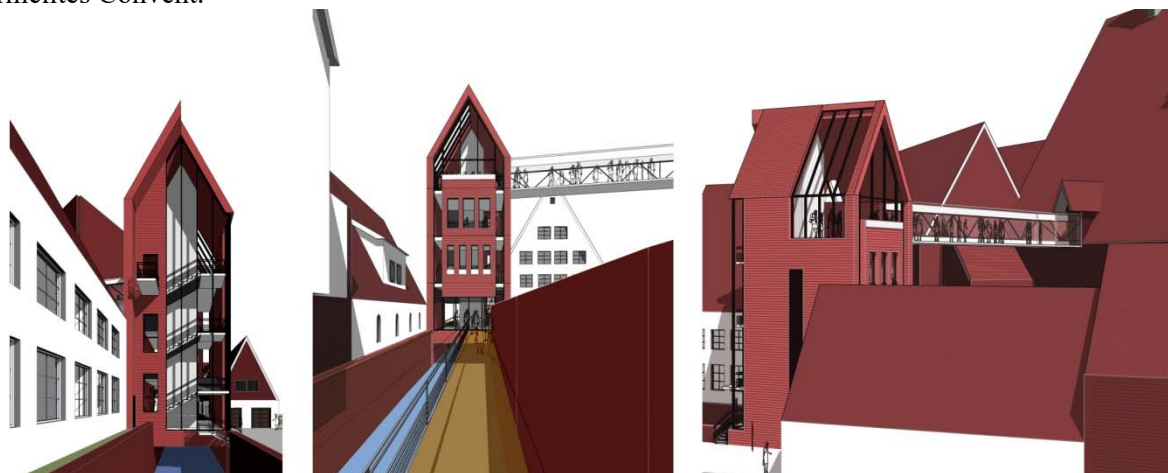
Figure 2. The new staircase building with the entrance area viewed from different perspectives.

building of the monumental Small Mill. The new construction was designed over the Radunia Canal, based on both sides of its structural walls (figure 2). This made it possible to ensure a representative approach to the entrance of the museum, while preserving the privacy of the site belonging to the Carmelites Convent.
