## TECHNOLOGICAL CONSIDERATIONS OF PERIODIC REPAIR WORKS OF CONCRETE INDUSTRIAL FLOORS

The paper presents a collection of practical information related to conducting periodic repair work on concrete industrial floors. The article is a case study and addresses specific situations related to the loss of serviceability of concrete industrial floors.

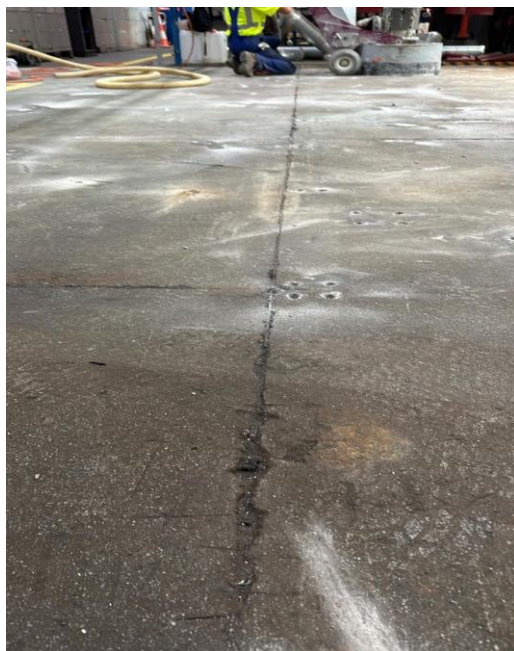
Example 1 is a floor in several years of use, located in a manufacturing plant in a section for welding steel components (Fig.2, Fig. 3).

Fig. 2. Degraded concrete industrial floor (Example 1): visible wear of the top layer, mounting anchors left over from equipment removal, and shrinkage joint damage [38]

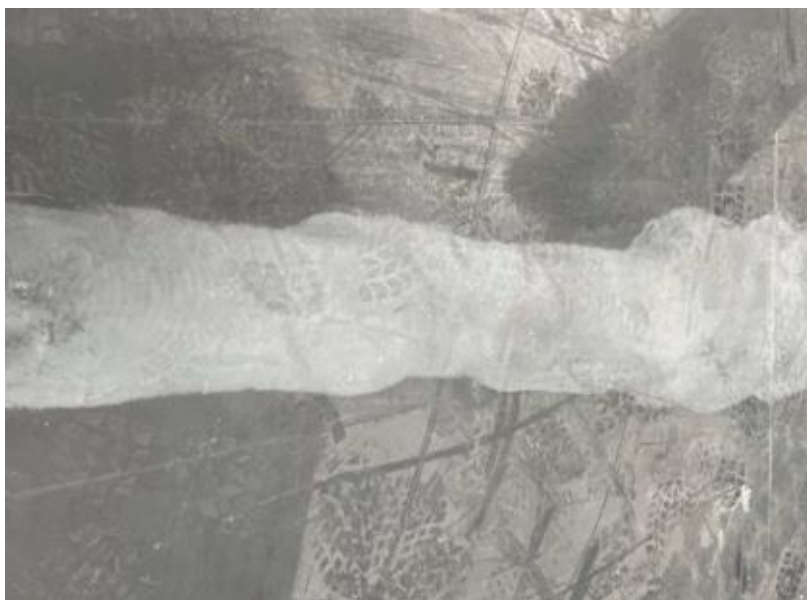
Fig. 6. Concrete industrial floor (Example 1) during repair: making an addition to the basin formed after the removal of the process channel [38]

Filling the cavities was done with the excess material, which was then removed by grinding (Fig.6). [1]

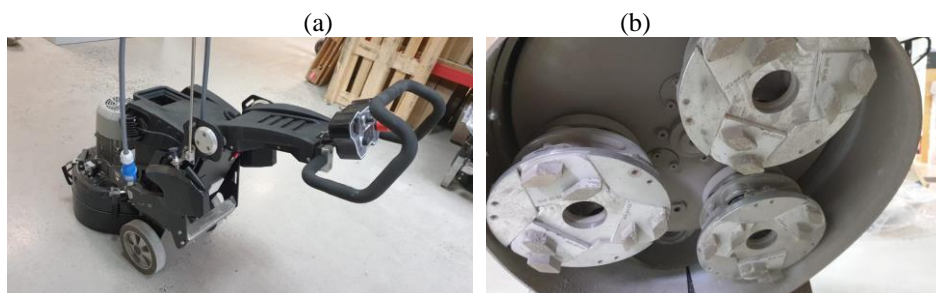
Fig. 7. Concrete floor grinding tool set (Example 1): a) grinding machine; b) machine planetario with visible metal segments [38]

After seasoning and drying of the repair material, which, depending on air humidity and ambient temperature takes 2-4 h, proceeded to coarse grind the entire surface with metal segments of gradation sequentially: 30 - 40 intended for hard concrete; then with metal segments of 60 -80 gradation to smooth out the scratches, and in the third step with metal segments of 120-140 gradation (Fig.7). At this stage, the grinding process was completed to remove the most degraded layer.

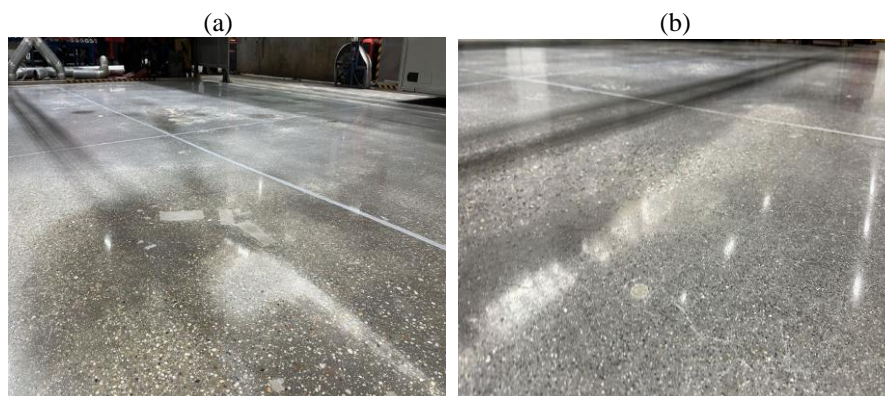
Fig. 8. Concrete industrial floor (Example 1) after repair: a) visible areas of repair of cavities b) visible areas of repair after anchors [38]

After drying, polishing was started with a white polishing pad using a high-speed polisher (Fig.8). To complete the work, the edges of the expansion joints were restored, and the expansion joints were filled with polyurethane compounds (Fig.9).

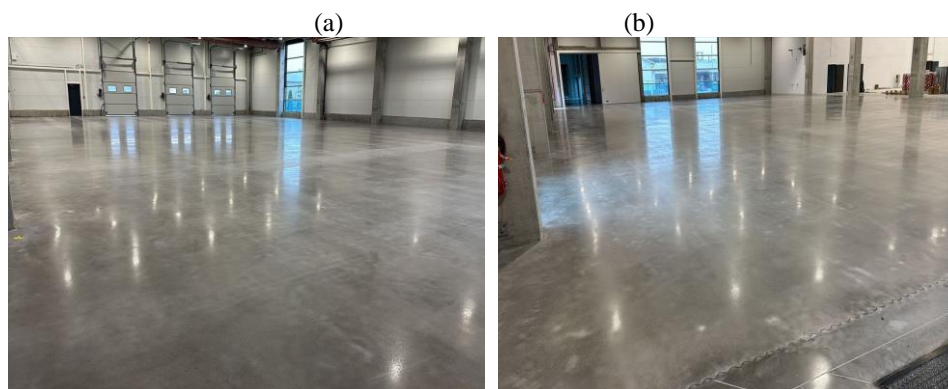
Fig. 13. Concrete industrial floor (Example 3) after regeneration by polishing and impregnation process: a) general view, b) view of pavement treatment in the area of structural expansion joints [38]

Due to the low level of wear and tear from use, the grinding process omitted the use of metal pads, and the entire restoration process began with grinding with plastic diamond discs with a gradation of 50 for honing. The floor was then reinforced with a silicate composite-based impregnant, and final grinding was performed with discs with gradations of 100 and 200, which increased its resistance to abrasion, intensive washing (Fig.13).

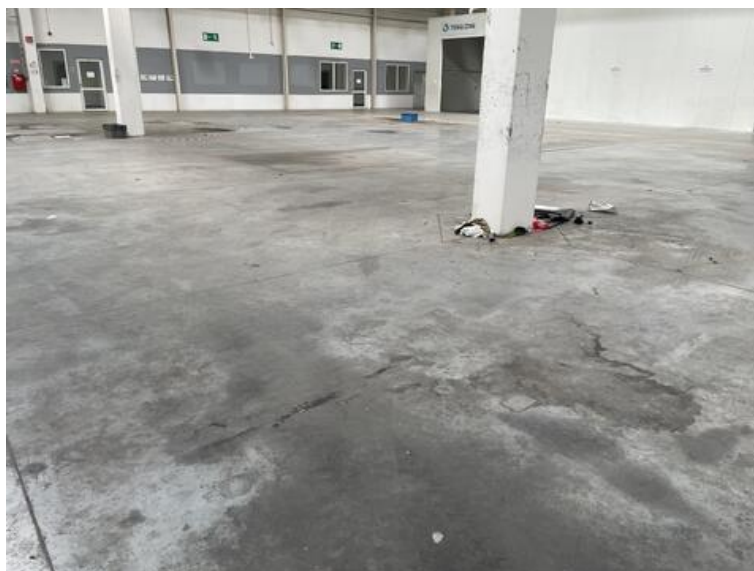
Fig. 14. Concrete industrial floor (Example 4) before renovation: damaged upper floor surface due to improper use of cleaning agents [38]

The ~6,800m<sup>2</sup> facility was in dry production, but leachate from machinery and equipment in the form of chemicals, oils and grease, permanently penetrated the floor structure (Fig.14). The floor required thorough washing and cleaning with specialized chemicals. Locally degraded parts required rough sanding, which took place on about 5% of the hall's surface. More than 6,000 anchors were removed from the floor, along with the repair of the areas after their removal. During the renovation work, it was found that all working expansion joints were subject to edge displacement and there was so-called slab keying associated with deformation and settlement of the substructure.

In the course of the work, a decision was made to repair the substructure and thus support the edges of the expansion joints by pressure injection, which was eventually carried out in the amount of ~1200 mb of expansion joints.

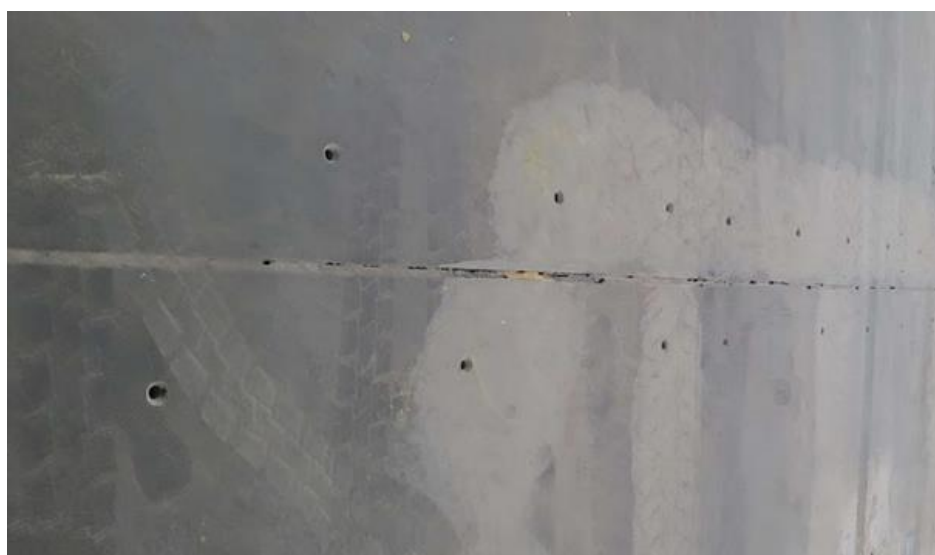
Fig.15. Concrete industrial floor (Example 4) during repair: diagram of drilled holes for injection feeding [38]

The repair by injection consisted of drilling ~14 mm diameter holes in the floor along the working expansion joints (Fig.15). The holes were drilled to the full thickness of the floor alternately on both sides of the expansion joints. The distance of the holes from the edge of the slab is ~30 cm, and the spacing between adjacent holes does not exceed 60 cm. At the corners of the slabs, it was recommended that the spacing be halved to maximize stabilization of the most sensitive areas.

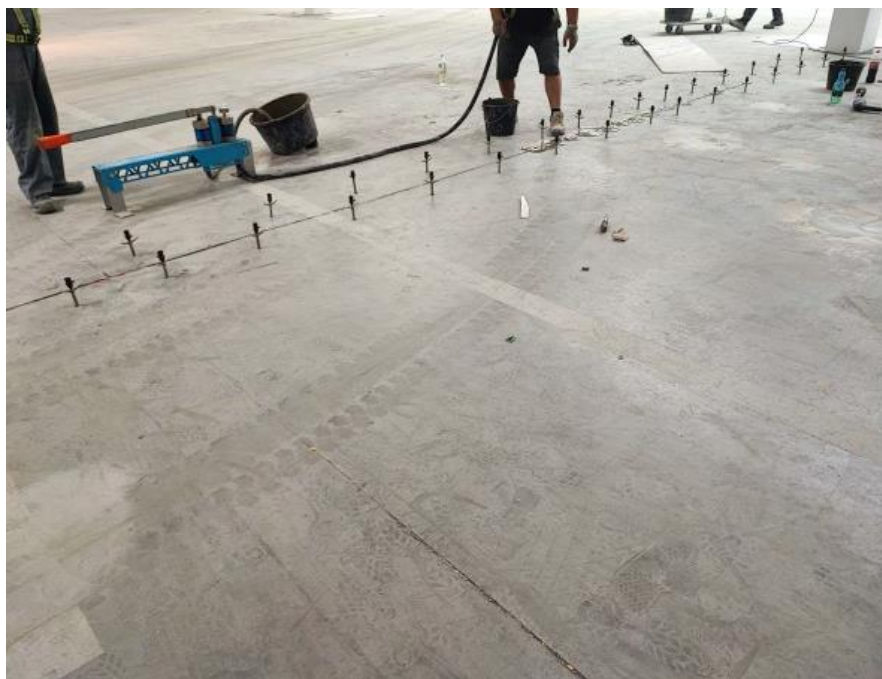
Fig. 16. Concrete industrial floor (Example 4) during repair: installation of packers and feeding of cement injection with a pump [38]

Control packers are made in the central part of the slab to monitor the consumption of the injectant (Fig.16). Then, through the drilled holes secured by the packers, the mineral cementitious liquid mass was applied using an injection pump.
